HISTORIC PRESERVATION COMMISSION

ALTERATION TO A HISTORIC PROPERTY STAFF REPORT

Site: 201 Central Street 1919-1925 Temple B'nai Brith
Case: HPC 2015.090 City of Somerville Preservation Restriction

Date of Application: December 21, 2015
Legal Notice: *Block two windows for installation of new elevator and replace one window with a door for new ADA entrance.*

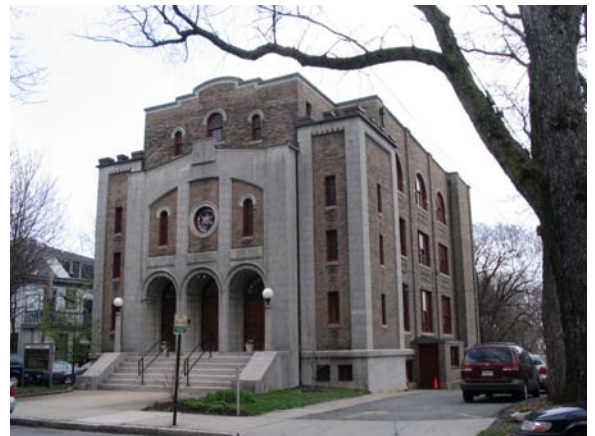
Possessing a distinctive, compact rectangular form, the synagogue measures three-bay's by-five-bays. Rising four-stories from a cast stone basement to flat-roofed structural components, the tripartite main facade features a trio of arched entrances set off by cast stone enframements. Access to the entrances is provided by a broad flight of concrete steps. The steps are flanked by high shouldered masonry components. Rising from atop these flanking components are original lighting fixtures in the form of tall cast stone columns supported by milk glass globes.

The center pavilion is characterized by a shallow three-bay projection from the main body of the building. Cast stone piers define the edges of the broad entrance bay. Flanking the entrance bay are narrow walls pierced by a single narrow window at each of their three stories. Above the arched entrances are three recessed panels that rise to the curving line of an arch. Set off by cast stone wall surfaces, the buff brick

panels are pierced by a center, circular stained glass window depicting the Star of David. The circular window is flanked by narrow arched windows. The center pavilion culminates in a broad, low arch. At the apex of the arch are two round-arched cast stone panels depicting an open prayer book. Set back behind the center pavilion and rising from the center of the segmental arched pediment

The center, three-story component is flanked by crenellation in evidence atop the narrow flanking bays. Ranged across the five bay side walls piers are corner pier-like structural components providing the structure vertical accents as well visually separating the tripartite windows at the first and second stories; these windows surmount rectangular brickwork panels. The tripartite windows of the side walls culminate in arches.

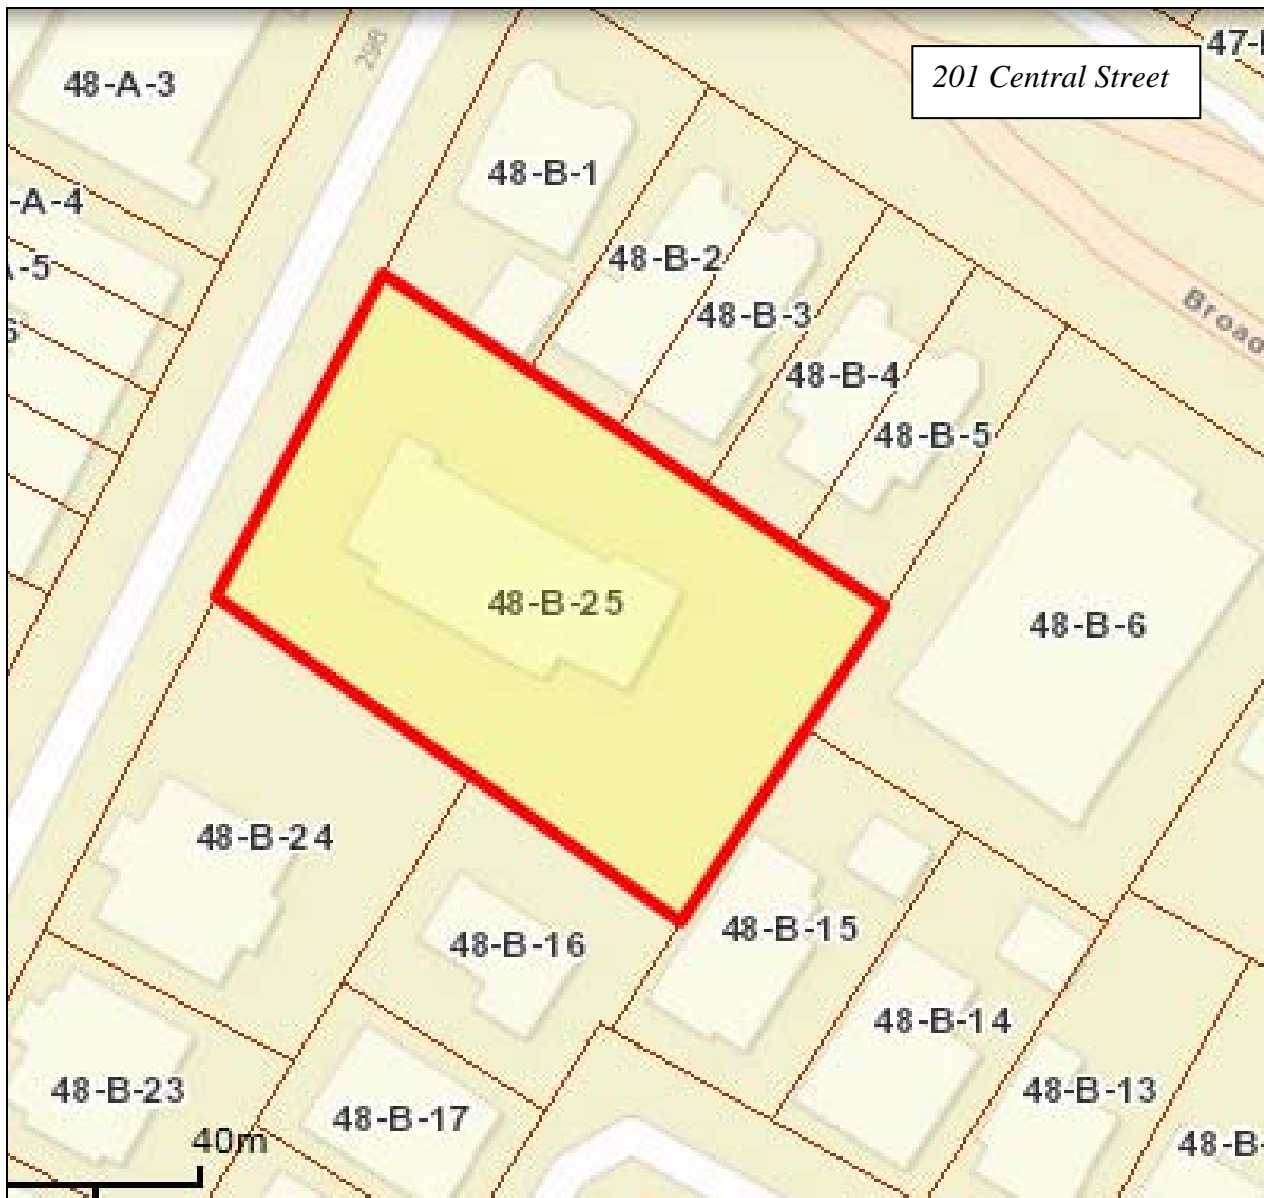
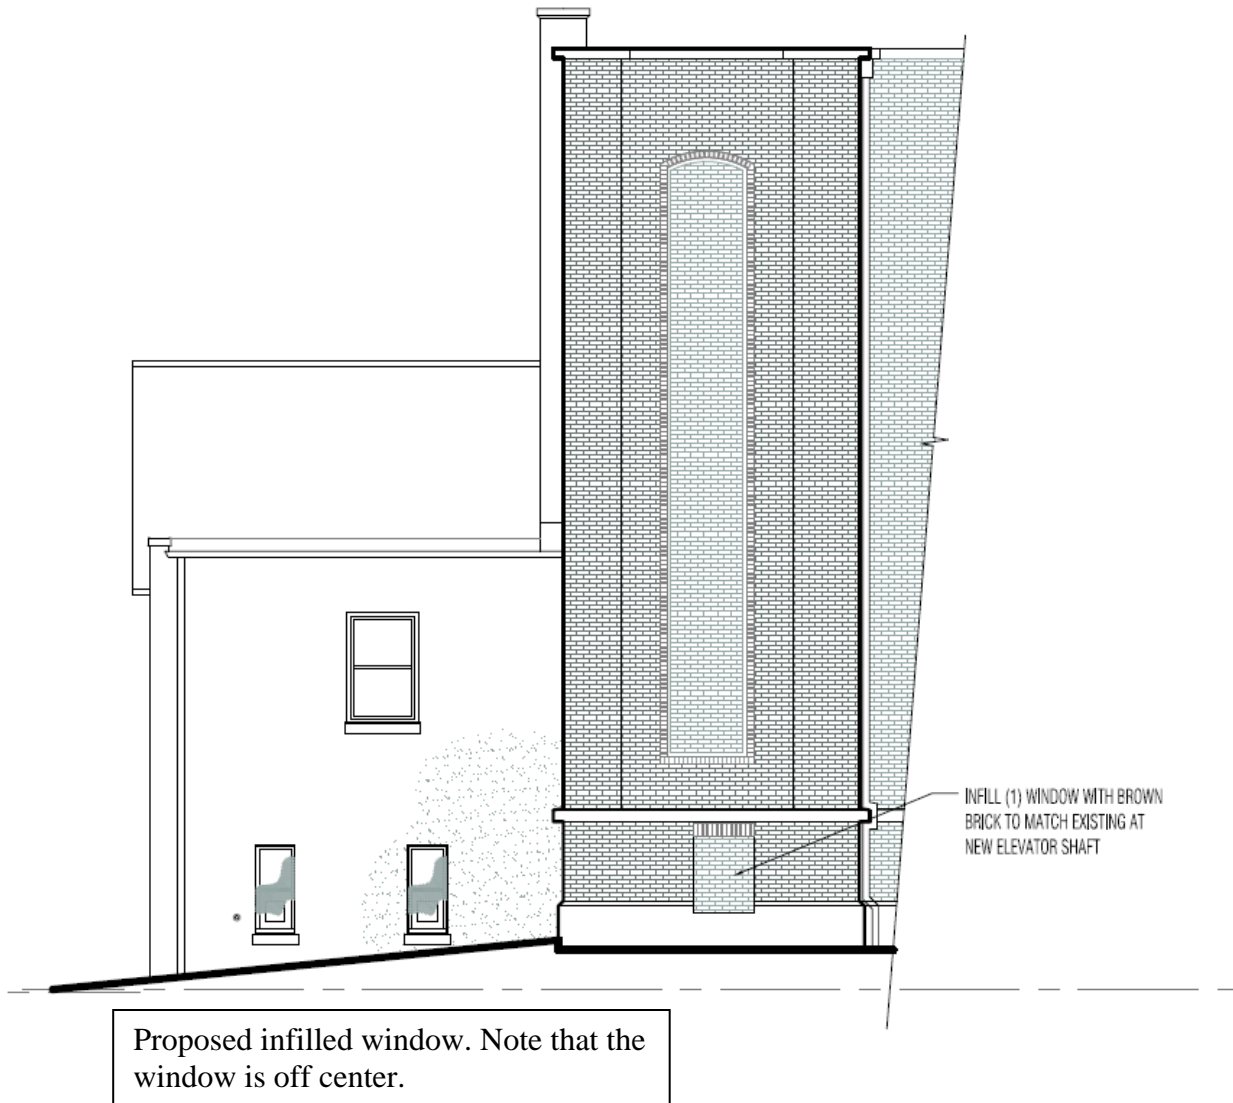
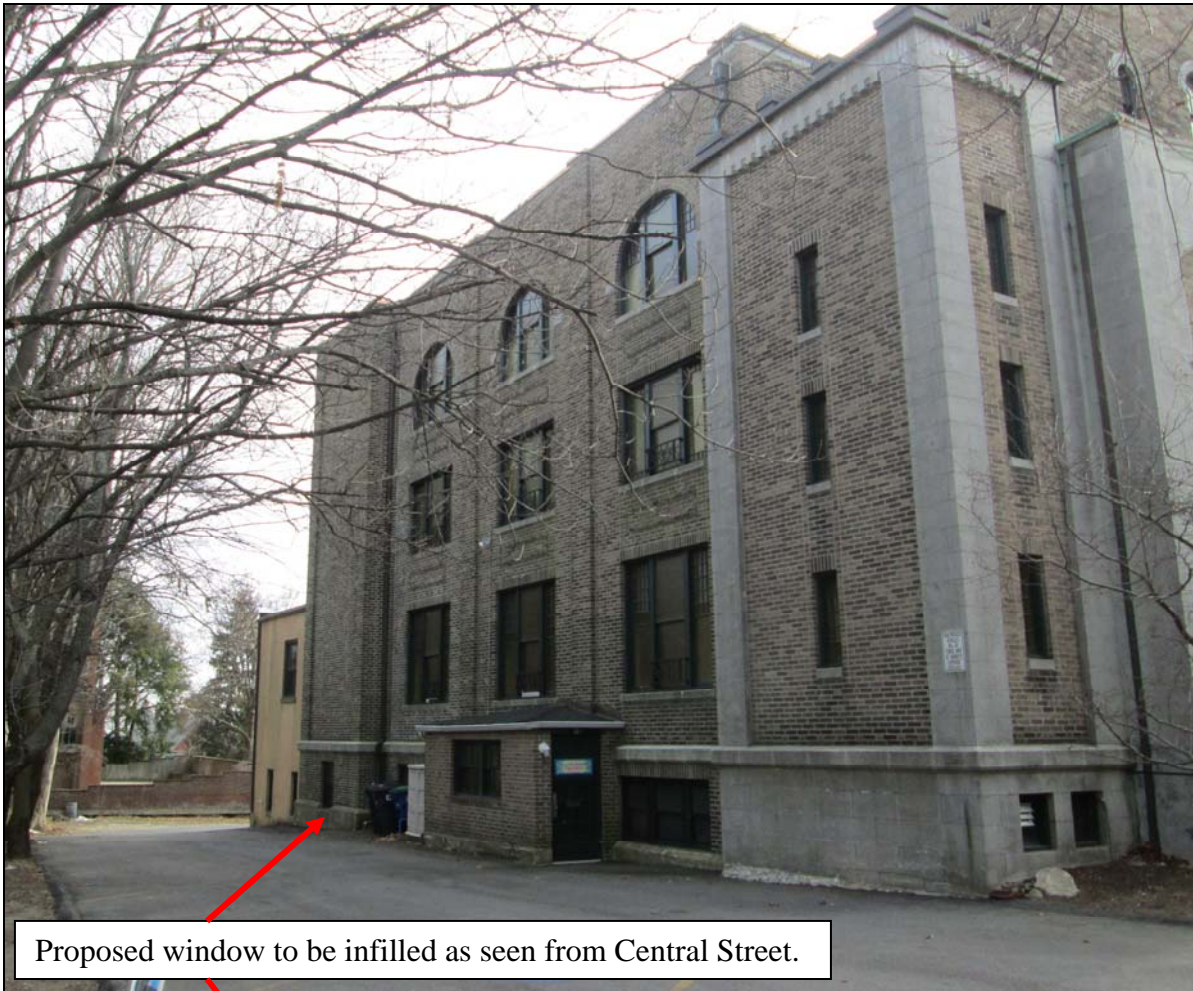
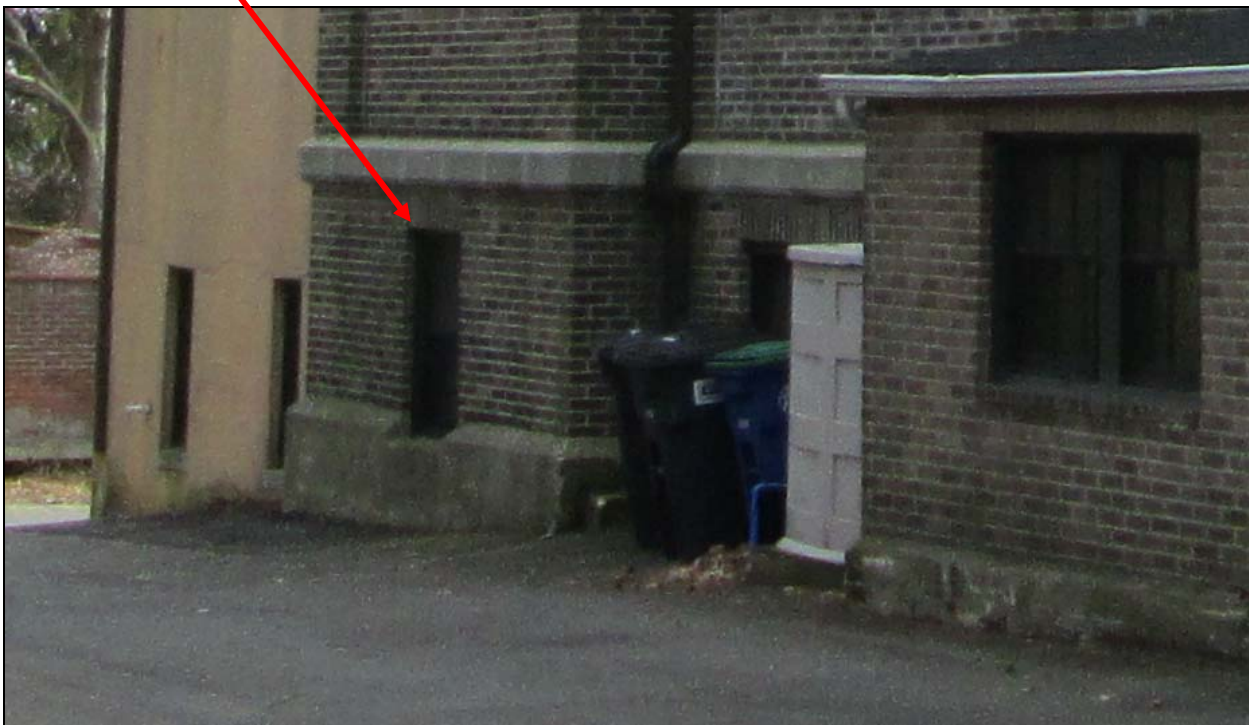
An elevator is required for access to the Temple by the disabled. This would be constructed entirely within the envelope of the current building. Windows would be altered to accommodate a new entry from the parking area and to enclose the elevator shaft. Only one of these alterations is visible from the public right of way near the rear northeastern corner of the building. See photo and plans below.

Most of the alterations would not be visible from the Street. The proposal would alter the appearance of the rear corner of the building making a flatter plane. The infill will match the existing masonry in color and texture

The sides of the building were not discussed in the Form B. While not discussed in the Form B, it is likely that the opening is not original to the building and indicated by its off-center location. No material will be removed from the portion of the building visible from the street only the rear addition where it would not be visible. A lower level window will be infilled with material to match the existing with shadow lines retained to show that there had been an opening at the rear northeast corner of the building.

Infilling the window opening completely with material to match the masonry wall does not meet the guideline to retain openings nor the guideline to retain the original window elements. The distance from the street and angle of view renders any window details moot. The window infill will be inset to retain the shadow of the opening and indicate its original location.

1. All appropriate building permits shall be obtained prior to the start of any work.
2. If the approval differs from the plans, new plans shall be submitted to Historic Staff prior to commencing the work;
3. The window at the northeast corner of the building abutting the driveway shall be infilled to match the masonry above in size, color, texture, mortar and pointing details.
4. The infill will be set to sufficient depth to retain the character of an opening as seen from Central Street.
5. Historic Staff shall issue a sign-off upon completion of the project that this was done in accordance with the Certificate and approved plans and prior to the Somerville Historical Society receiving Inspectional Service Division sign off.
