CITY OF SOMERVILLE, MASSACHUSETTS  
OFFICE OF STRATEGIC PLANNING & COMMUNITY DEVELOPMENT  
JOSEPH A. CURTATONE  
MAYOR

**ALTERATION TO A HISTORIC PROPERTY STAFF REPORT**

Site:	53 Columbus Avenue	c.1874 Second Empire House
Case:	HPC 2013.075	Columbus Ave. / Warren Ave. Local Historic District
Applicant Name:	RCG Columbus Renewal LLC, Owner	
Applicant Address:	17 Ivaloo Street, Somerville, MA 02143	
Date of Application:	July 30, 2014	
Legal Notice:	Replace 2 chimneys	
Staff Recommendation:	Denial without prejudice	
Date of Public Hearing:	August 19, 2014

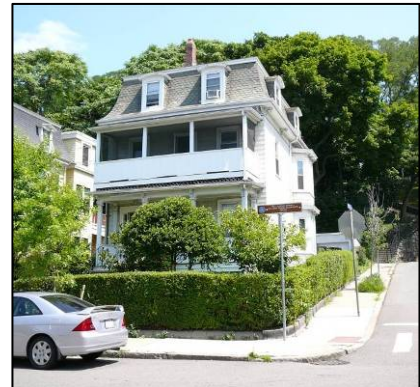
**53 Columbus Avenue 2014**

*One of the most popular building styles in the Prospect Hill area during the 1870s and early 1880s was the Second Empire style for large center-hall or side-hall entrance dwellings. The concave mansard roof retains its decorative hexagonal slates. There are two segmental arched dormers on each side exposed to the corner intersection.*

*In spite of the asbestos shingled siding the house retains some of its Second Empire characteristics including its most distinctive feature of a decorative slate roof, paired cornice brackets, a two-story octagonal side bay and squared porch columns with capitals and brackets with drop finials.*
