ALTERATION TO A HISTORIC PROPERTY STAFF REPORT

Site: 20 George Street c.1880, Lattimore-Pratt House

Case: HPC 2016-029 Single building Local Historic District

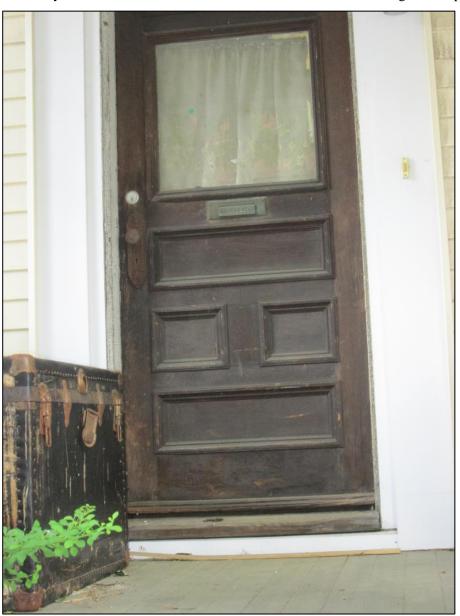
The door below shall be removed from 23 Cleveland Street (to be demolished) and repurposed for re-use on the secondary entrance on the Lincoln Avenue elevation of the 20 George Street property.

- (4) Replace Lincoln Ave. secondary door with a period-appropriate door to be salvaged from 23 Cleveland Street (door is c.1870s/1880s and is appropriate for use as a secondary entrance door).

- 5. A door shall be salvaged from an existing property of the same period and shall be revitalized to be used as a secondary entrance on the Lincoln Avenue side of the property;

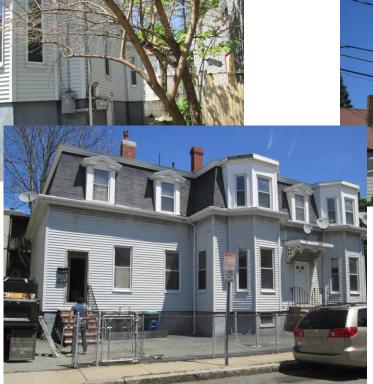
Below: George Street facade

The house has been under-maintained for the last 20+ years. The vinyl siding, removal of slate roofing, replacement of period doors, removal of decorative door hood on George Street, installation of inappropriate replacement windows, and the paving over of the entire yard have all detracted from the historic integrity of the property.

The photos below represent the current conditions at 20 George Street:

- (2) Replace George Street front door with period-appropriate double-door.
- (3) Replace Lincoln Ave. font door (the door with the decorative hood) with period-appropriate double-doors.

- 13 Remove chimney on right George Street elevation. Remaining three chimneys will be retained and repaired.
 - See the final pages for details and photos.

- 8. Only one of the four chimneys shall be removed that which is located on the front right of the George Street elevation. All other chimneys shall be repaired in-place with the proper materials (to be approved by Preservation Staff);
