**DETERMINATION OF PREFERABLY PRESERVED STAFF REPORT**

Site: 82 Highland Avenue

Case: HPC 2013.083

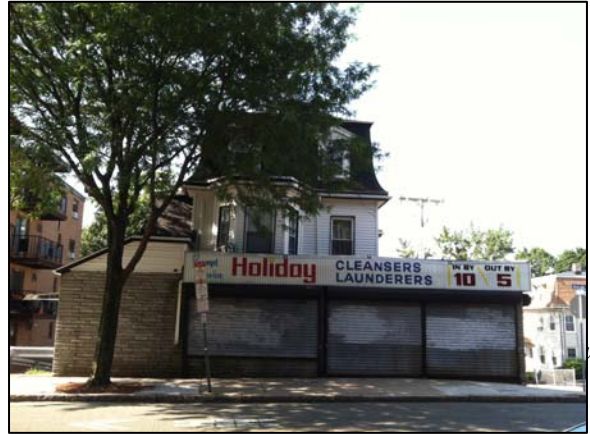
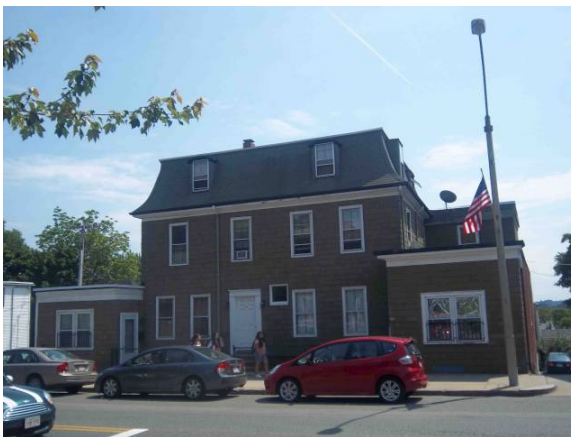
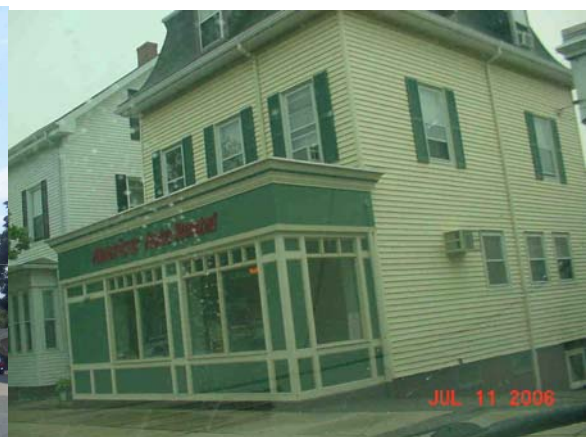
Left to right: 84-86 Highland Avenue, 90 Highland Avenue,

Predominant differences between the comparable nearby buildings and the subject building are in the individual arrangements. 84-86 Highland Avenue shows the storefronts added to either side of the house; 90 Highland Avenue has the retail/office space added to the front of the building; 2 Prescott shows a fully gutted ground floor with a side entry for the residential portion; and 54 Summer Street exhibiting the raised building variation common in the 1920s and 30s.

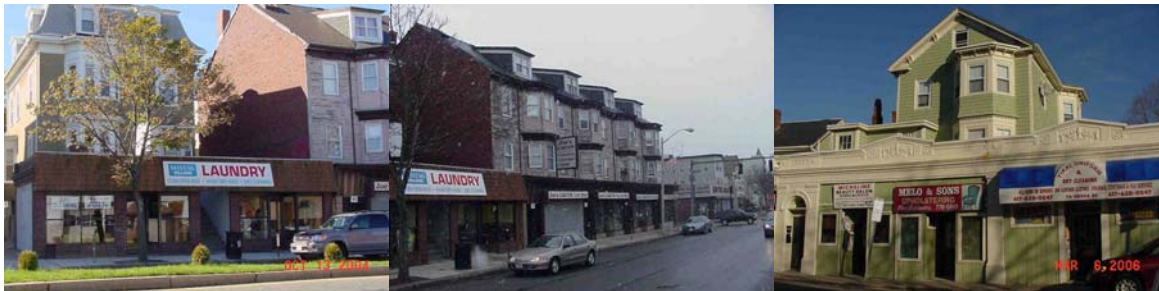
Left to right: 158 Broadway, 160 Broadway, 126 Pearl Street

Examples from elsewhere in the City, show a similar pattern of alterations. The buildings below have all been raised up to allow for ground floor retail. 126 Pearl Street is dated 1922 on a parapet pediment.
