HISTORIC PRESERVATION COMMISSION

DETERMINATION OF SIGNIFICANCE STAFF REPORT

Site:	0 Morgan Street, 193 Beacon Street Garage
Case:	HPC 2016.024
Applicant Name:	Clayton Peabody
Date of Application:	April 8, 2016
Recommendation:	Significant
Hearing Date:	May 31, 2016

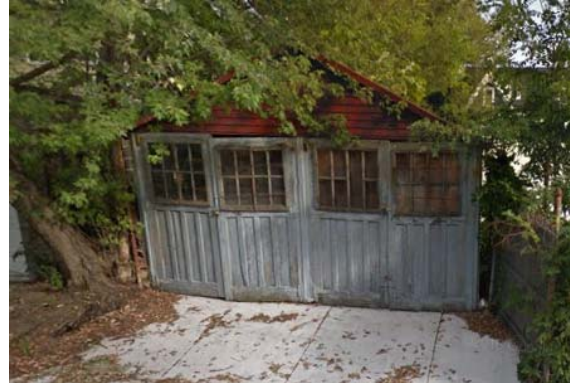
Architectural Description: 0 Morgan Street/ 193 Beacon Street is a one-story pre-fabricated metal garage with 2 wood double-doors, each with 8 'lites' and four vertical panels. The siding is faux clapboard panels. There is a pitched red metal roof.

The subject building is found historically and architecturally significant as a good example of the pre-fabricated metal garages constructed in the late 1920s. It retains its original doors and metal roof.

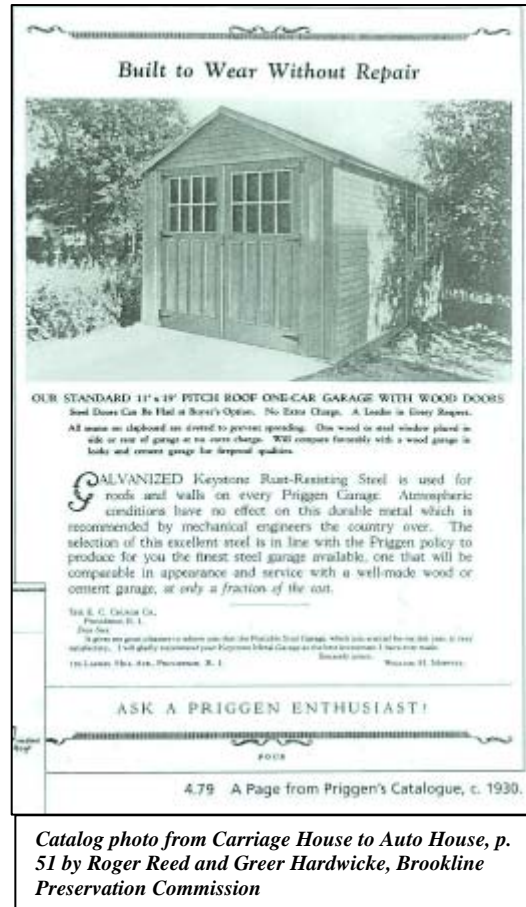
Catalog photo from *Carriage House to Auto House*, p. 51 by Roger Reed and Greer Hardwicke, Brookline Preservation Commission
