CITY OF SOMERVILLE, MASSACHUSETTS
OFFICE OF STRATEGIC PLANNING & COMMUNITY DEVELOPMENT
JOSEPH A. CURTATONE
MAYOR

ALTERATION TO A HISTORIC PROPERTY STAFF REPORT

Site:	34 Spring Street	c.1852 Robinson-Lovejoy-Hodgdon House
Case:	HPC 2015.048	CASS Local Historic District
Applicant Name:	J. Murray & Sons, Contractor	
Applicant Address:	114 Broadway, Somerville, MA 02145	
Date of Application:	July 22, 2015	
Legal Notice:	<i>Alter siding</i>	
Staff Recommendation:	Certificate of Appropriateness	
Date of Public Hearing:	August 18, 2015

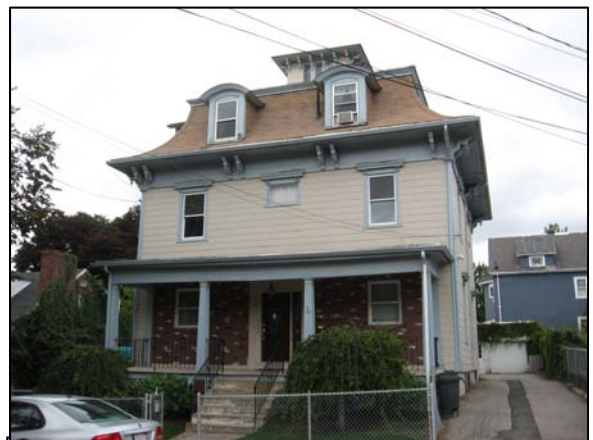
34 Spring Street, 2009

34 Spring Street stands on elevated terrain, mid-way up the south slope of Spring Hill. Overlooking a narrow, shrub-dotted front yard, 34 Spring Street is a T-shaped, two story Italianate villa. Rising from a brick

foundation to a bell-cast mansard roof, the mansard is crowned by a square cupola. The house is composed of a three-bay-by-two-bay main block and a two-story three-bay-by-one-bay rear ell. The edges of the main block are accented by narrow corner boards. Turning to the center of the main facade's first story, the front door is set off by simple vertical and horizontal boards, which in turn, are flanked by Doric pilasters; these flanking pilasters are echoed in the pilasters in evidence at either end of the main facade's first story. The replacement front door of the center entrance bay opens onto a full-length front porch. The porch floor rests on a wooden platform and supports square replacement posts that rise to support a flat roof. On either side of the front door are foreshortened windows that were originally full length. These windows were apparently altered during the c. mid twentieth century when asphalt sheathing replaced original clapboard sheathing. In general, windows are standard size and are fully enframed--complete with cornice-headed lintels (main block only). The house's windows contain 111 double-hung replacement metal sash. In addition to the main facade's first story windows, the window at the center of the main facade's second story has also been reduced in size. The facades of the main block culminate in deep bracketed cornices. While the main and south roof slopes retain original pairs of dormers with arched roofs, the dormers on the north slopes were removed to accommodate a pair of skylights.

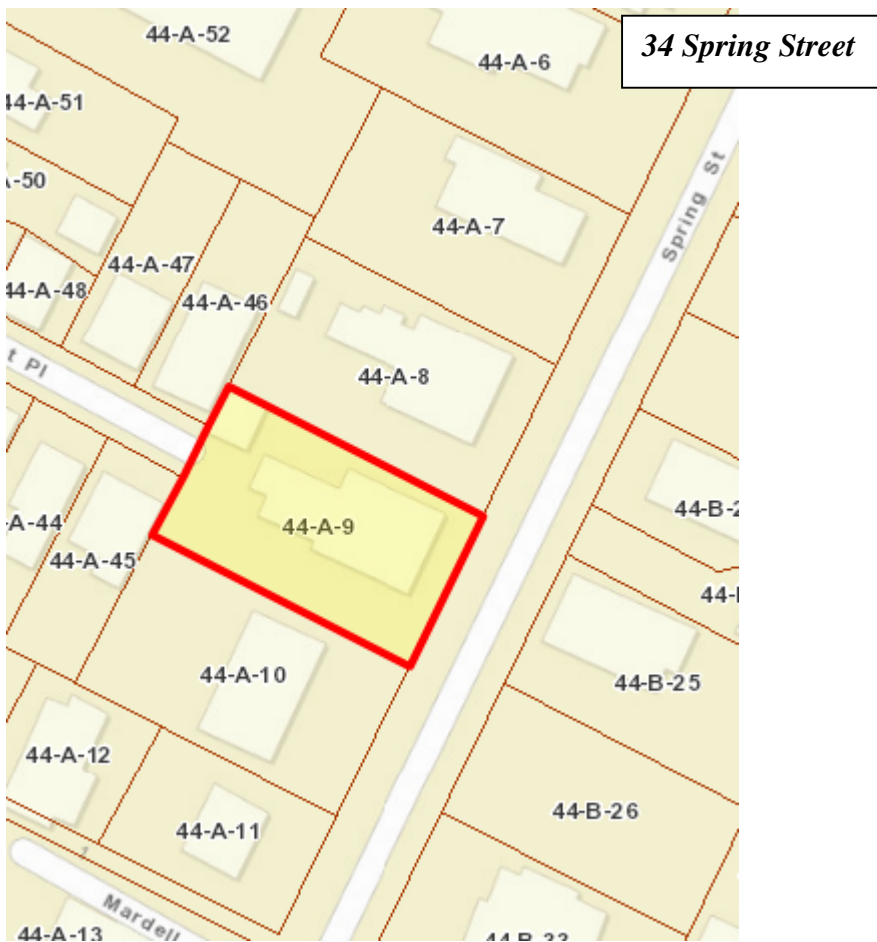
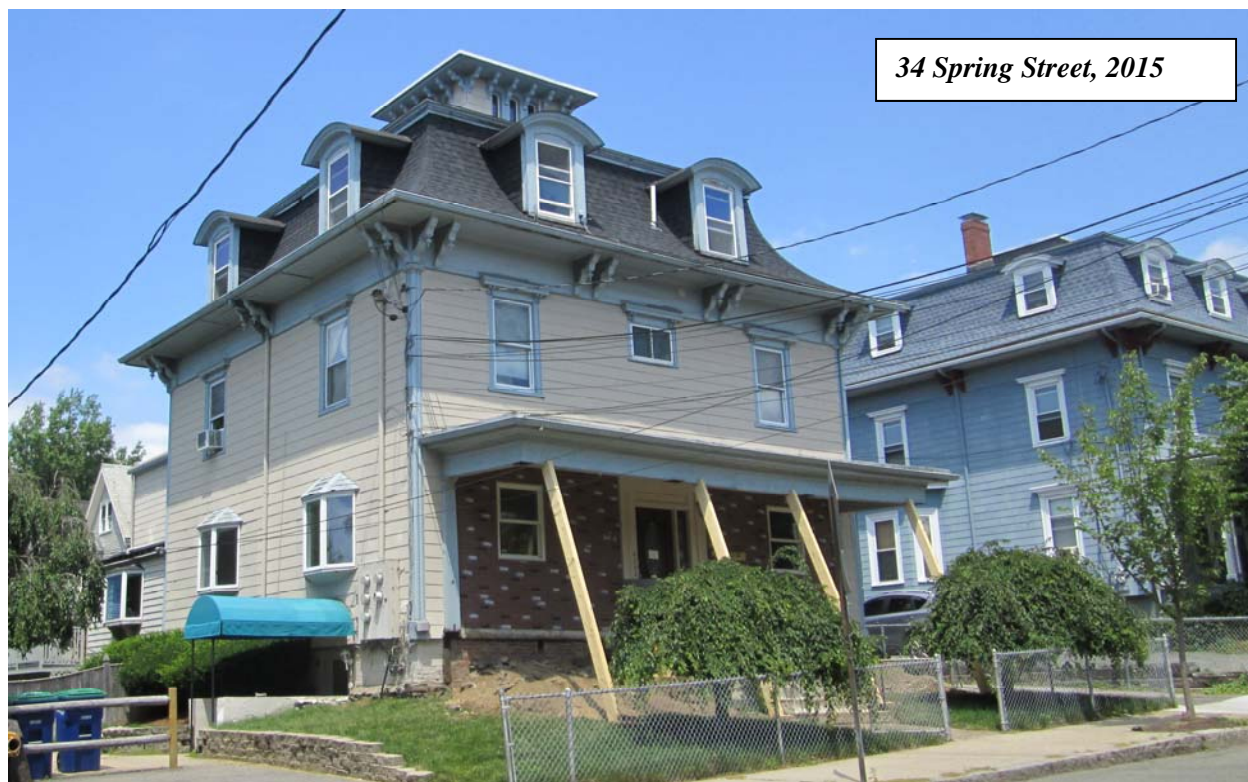
34 Spring Street, 2015

The wall is visible from Spring Street and is located beneath the second floor porch..

The house is located halfway down Spring Street and adjacent to a very similar house in a residential neighborhood. The condominium association is undertaking extensive porch and deck repairs. The wall of the house under the

porch is covered with synthetic brick. The remaining walls of the house are covered with asbestos shingle. See photos at the end of the document.

The synthetic brick siding is inappropriate for the building. The proposal will return the siding to wood clapboard in-keeping with the original materials of the building.

1. The synthetic brick siding shall be removed.
2. Wood clapboard shall be installed on the first floor front wall to match the evidence of the clapboards found beneath the synthetic brick in exposure and installation.
3. Historic Staff shall issue a sign-off upon completion of the project that this was done in accordance with the Certificate and approved plans.
