ALTERATION TO A HISTORIC PROPERTY STAFF REPORT

Site: 24 Summer Street c. 1870 Odiorne-Langley House
Case: (HPC 2015.034) Union Square Local Historic District

Legal Notice: *Alter front entry including door and walkway; Alter driveway; Add wood fence and gate.*

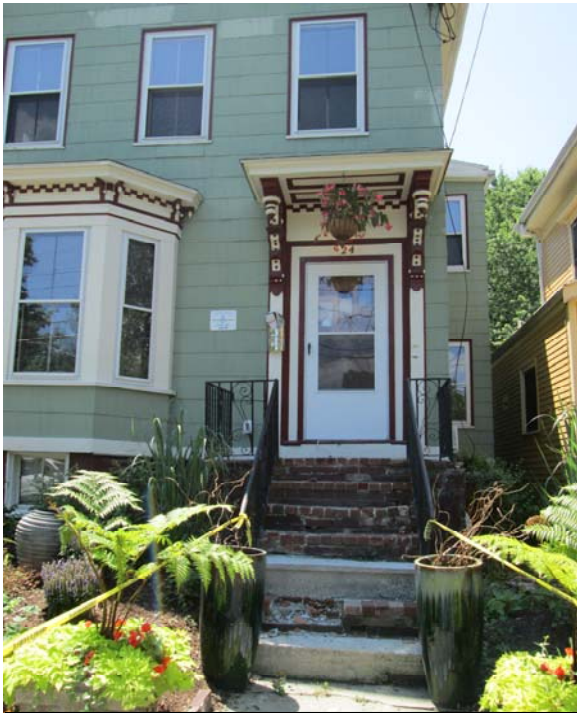
24 Summer Street front steps and walkway

- *What is the visibility of the proposal?*
The fence, driveway, walkway, stairs, porch and door are all visible from the public right of way.
- *What are the Existing Conditions of the building / parcel?*
There is no fence. The driveway is asphalt; the walkway, cement; stairs and porch landing are brick. The door is a 1960s replacement. The brick steps and landing are in poor condition. See photos at the end of the document.

1. The front door will be replaced by Vintage Door style G121.
2. The brick front porch and stairs with iron handrails shall be replaced by a new wood porch with new posts, railings, and balusters shall *exactly match those on the front of 45 Vinal Avenue in construction, size, shape, proportion, detail and material as per attached photo.*

3. The dimensions of the front porch shall match the existing of approximately 4' x 8'.
4. The skirt of the porch shall be wood.
5. The driveway shall have an apron of granite with real brick pavers in a pattern to be determined.

6. The walkway shall have real brick pavers to be determined.
7. The fence and gate shall be Charles and Concord as located in the site sketch provided by McDonough Fence dates 4/30/2015 and as shown on <http://www.mcdonoughfence.com/wood.html>

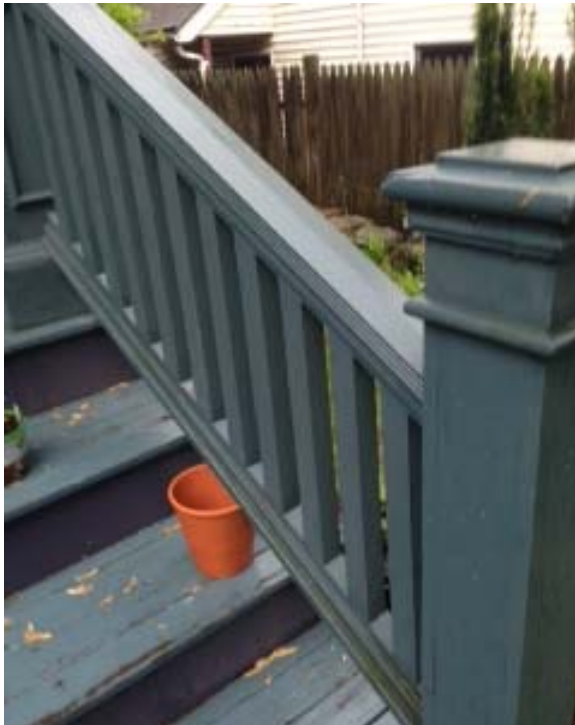
45 Vinal Avenue post, railings and balusters.

There are no original features to retain. The Applicant intends to use the simple generic posts, rails and balusters which would match those at 47 Vinal Avenue. The porch and stairs would also be constructed of wood in a traditional manner replacing the modern and crumbling brick steps.

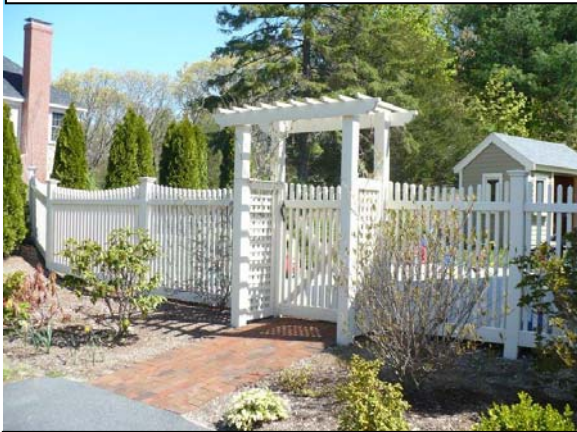
Charles fence, gate and trellis

There are no alterations to the essential landscape features. There are no changes to the layout of the pathway and driveway. The new granite and brick driveway and pathway will not alter the essential integrity of the house or the district. The Applicant would like to lay a decorative brick design but has not yet determined the pattern. The fence would be a combination of 'Charles' and 'Concord' styles by McDonough Fence Co. and would rise from 4' at the sidewalk edge to 6' at the end of the driveway and around the property line.

8. The pergola/trellis shall be the Concord as shown <http://www.mcdonoughfence.com/images/arbors/large/2.jpg>
9. If the approval differs from the plans, new plans shall be submitted to Historic Staff prior to commencing the work.

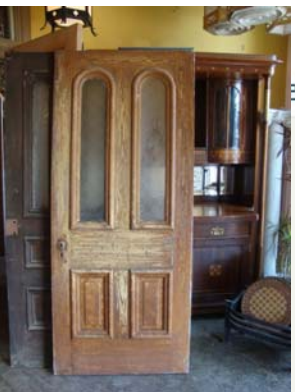
G121

Salvage door serving as example
