CITY OF SOMERVILLE, MASSACHUSETTS
OFFICE OF STRATEGIC PLANNING & COMMUNITY DEVELOPMENT
JOSEPH A. CURTATONE
MAYOR

ALTERATION TO A HISTORIC PROPERTY STAFF REPORT

Site: 117 Washington Street c.1789-1792 Samuel Ireland House
Case: HPC 2015.045 Single Building Local Historic District

Date of Application: July 21, 2015
Legal Notice: Replace 3-tab asphalt with architectural shingle roof
Staff Recommendation: Conditional Certificate of Appropriateness
Date of Public Hearing: August 18, 2015

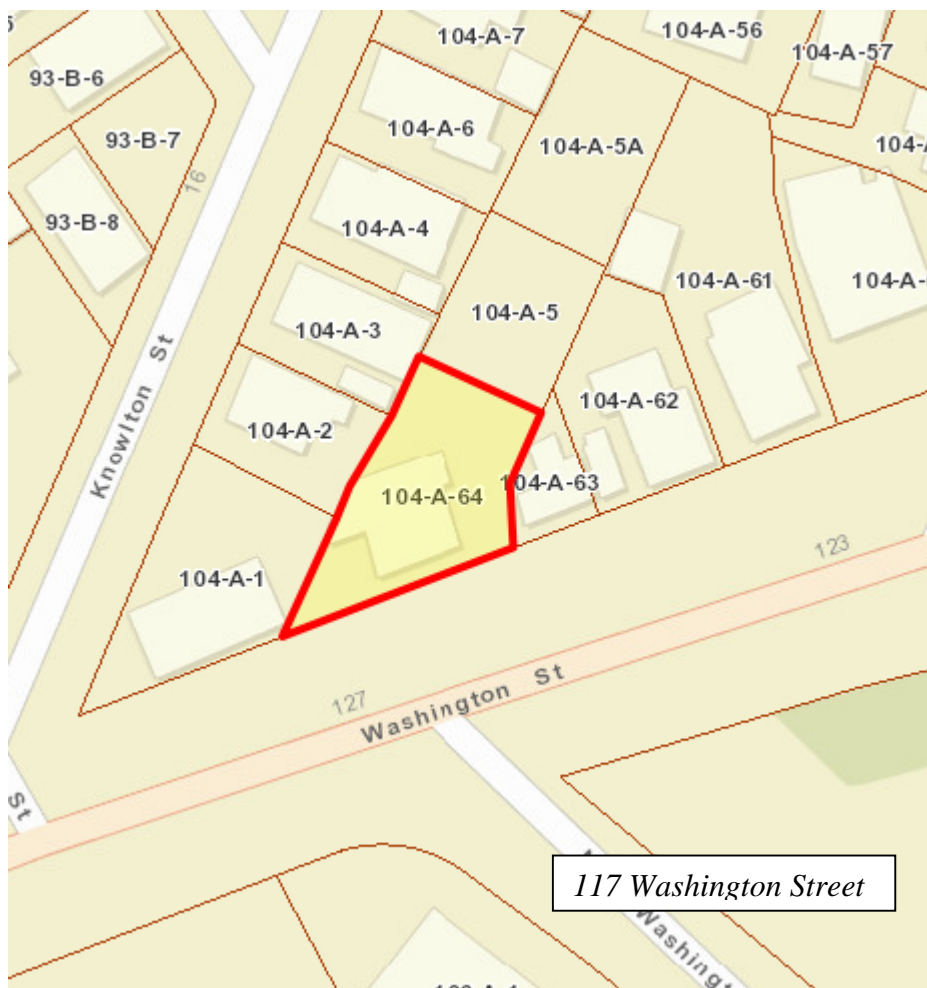
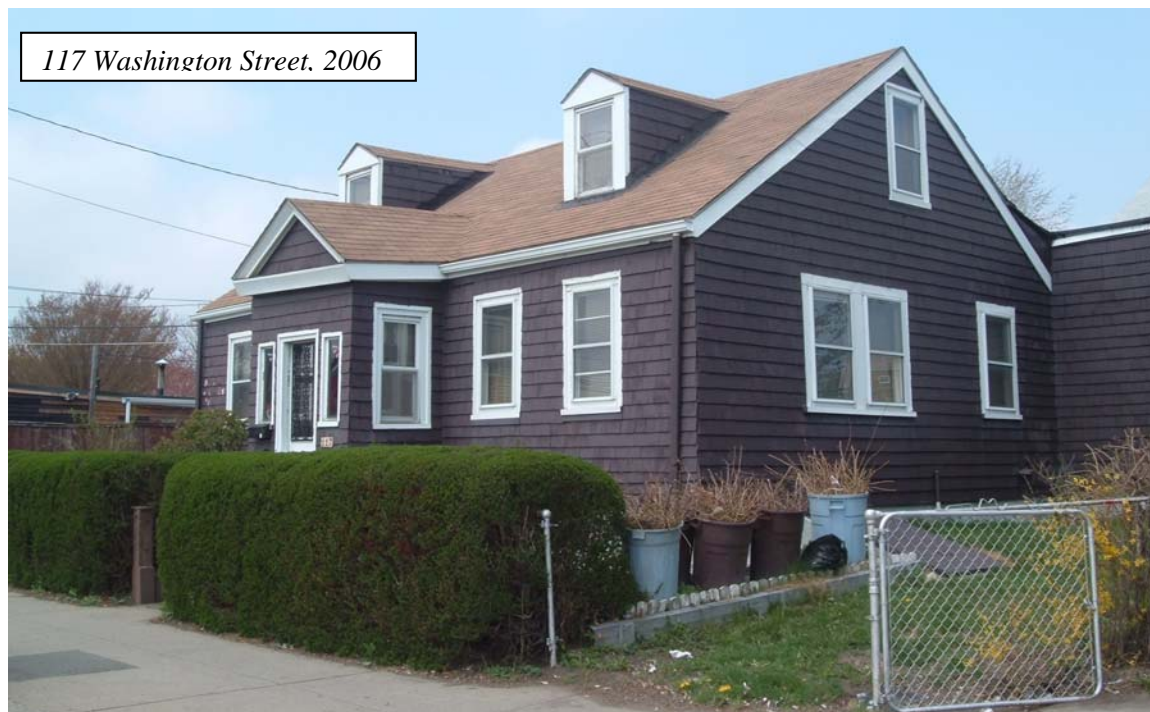
The Owner bought this house in a foreclosure in 2011. This property, located on a major local arterial, has been under a very delayed construction schedule. The roof has been replaced sometime between August 2013 and August 2014 with 3-tab shingles on a Certificate issued in 2011. Not all the items granted a Certificate of Appropriateness by the Commission have been undertaken such as the faux chimney which was to replace the one taken down in order to construct dormers on the rear of the building.

The original roof had wood shingles as can be seen in the photo below.

3. The roofing material shall be Slateline® in English Gray, Antique or Weathered Slate color.
4. Flashing shall be copper or terne metal.
5. No flashing or drip edges shall protrude more than ½" along the eaves.
