ALTERATION TO A HISTORIC PROPERTY STAFF REPORT

Address: 9 Westwood Road
Case: HPC 2014.050
Applicant: Marya & Kevin Outtersen
Address: 9 Westwood Road

Date of Application: June 26, 2014
Legal Notice: *Install vents and chimney cap.*

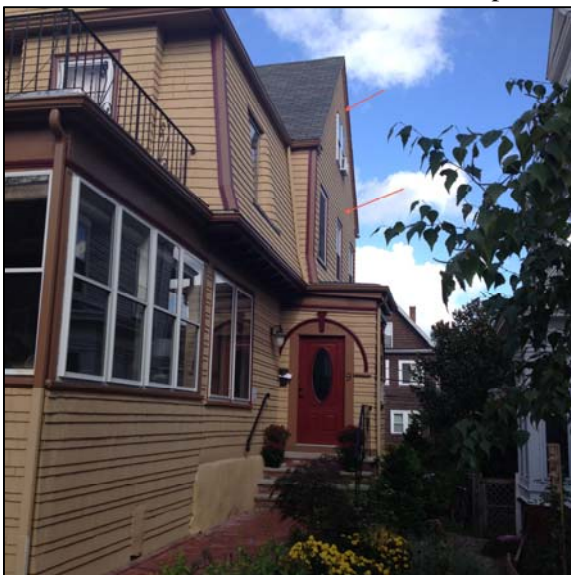
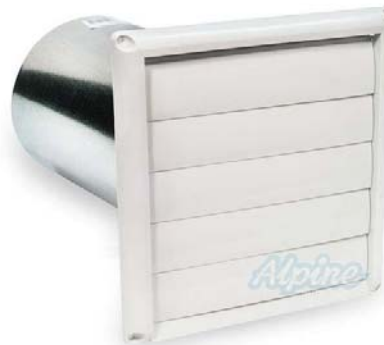
- The Applicant no longer proposes to install a chimney cap.
- The Applicant proposes to install two bathroom exhaust vents, which will be flush with the building and louvered, to be located on the right side façade within the projecting gable, see photo. Staff recommends a condition to paint the vents upon installation.

*Left: Location of flush louvered vent
Above: Proposed louvered vent to be painted*

- *Visibility:* The attic vent will be highly visible while the two bathroom vents will be less visible as these are proposed on the right side façade. In addition, the proposed bathroom vents are flat against the façade and louvered, so they will be less visible than a projecting vent.
- *Existing Conditions:* The house is located on Westwood Road, a district with multiple Shingle style houses developed in the 1890s. The house has been preserved well over the years as several prior certificates illustrate.
- *Does the proposal coincide with the General Approach set forth in the Design Guidelines?*

The architectural features will not be altered. The attic and bathroom vents are recommended to be painted to ensure minimal visibility from the street. The attic vent does remove a small portion of the shingled exterior; however, this vent will further the long-term preservation of this home and is not detrimental to the building. The bathroom vents are minimally visible from the street due to the flat quality of the vent. All vents should be painted to match the exterior.

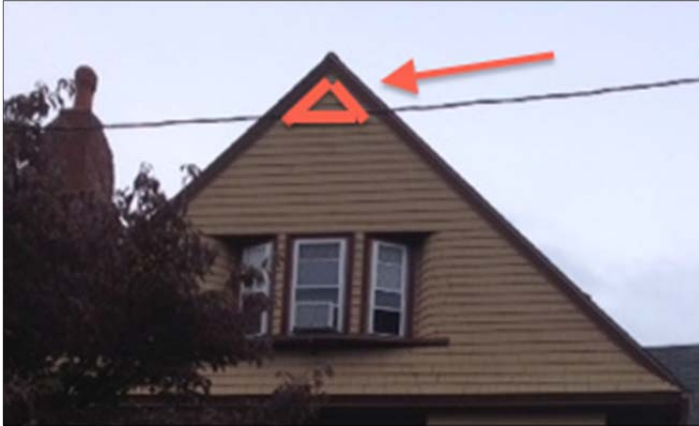
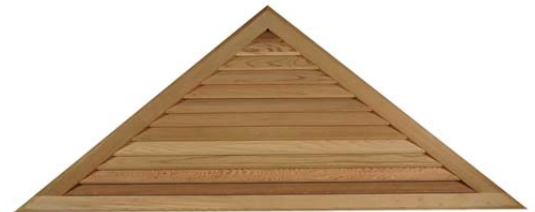
- The Applicant proposes to install an attic fan (not visible) and vent on the front façade, directly beneath the gable. The professionals working with the Applicant recommend this vent so the air can exit the attic. For a fan of the appropriate size, two square feet of additional “net free venting” space is necessary. The Applicant proposes a small roof gable vent as shown below, with a total height of about 25 inches. The vent will be composed of wood and Staff recommends a condition to paint the vent upon installation.

Left: Location of attic vent
Bottom: Attic vent proposed
