ALTERATION TO A HISTORIC PROPERTY STAFF REPORT

Site / District(s) 9 Westwood Road, c. 1896 Charles Lamb House, Westwood Road LHD
Case: HPC 13.005

Date of Application: 1/29/13
Legal Notice: *Change concrete walkway to City Hall pavers.*

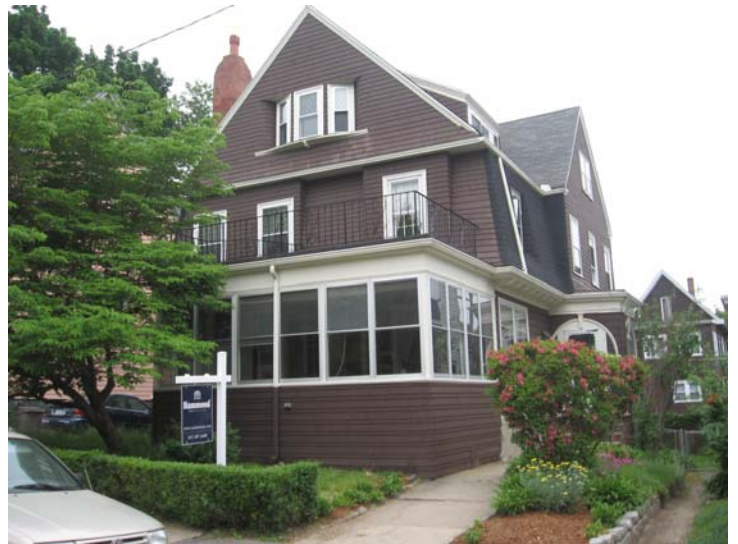
9 Westwood Road is one of the best preserved examples of the Shingle Style on Westwood Road. Rising from a prominent stone foundation and clad in wood shingles, this two and one-half story front gabled house is rectangular in plan. The facade is two bays wide with a one-story bay window on the first floor. The off center entrance has been obscured by an enclosed porch that also encompasses a portion of the bay. While the facade of this house has minimal architectural detailing, typical of the Shingle Style; the second floor exhibits unique variations in the wall plane. The building wall, which projects slightly over the first floor, is constructed at a slightly recessed angle, while the three second floor windows continue the vertical plane of the upper third story. This results in the appearance of shallow dormers under the projecting third floor. In the gable, a recessed semi-hexagonal bow window is framed by curved walls, a characteristic element of the Shingle Style. The west elevation is demined by a two-story round turret with conical roof. The turret consists of a four-part window with stained glass transoms on the first floor and a stepped series of narrow elongated rectangular windows recessed into the wall surface on the

second floor. The second story windows on this elevation are recessed into the angled wall, in contrast to the projecting windows on the facade. An exterior chimney, which is fieldstone on the first floor and brick above, completes the west elevation.

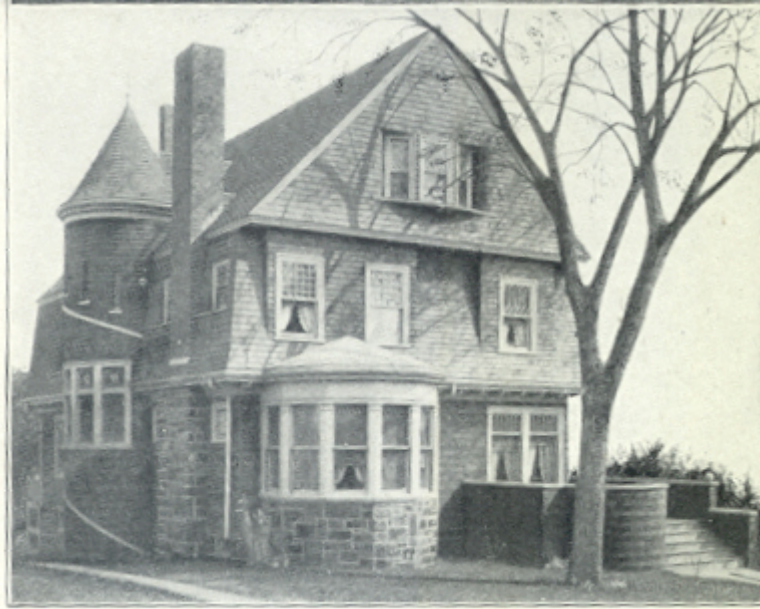
This house is located on Westwood Road, a district with multiple shingle style houses developed in the late 1890s. The concrete pathway is undistinguished but appears to be a replacement of the one seen in the c.1898 photo of the house from Somerville Past and Present which seems to have a raised edging. Its material is not discernable in the photo.

The replacement material does not match the highly visible existing walkway which is not original. It is difficult from the existing historic photo to determine the paving material.

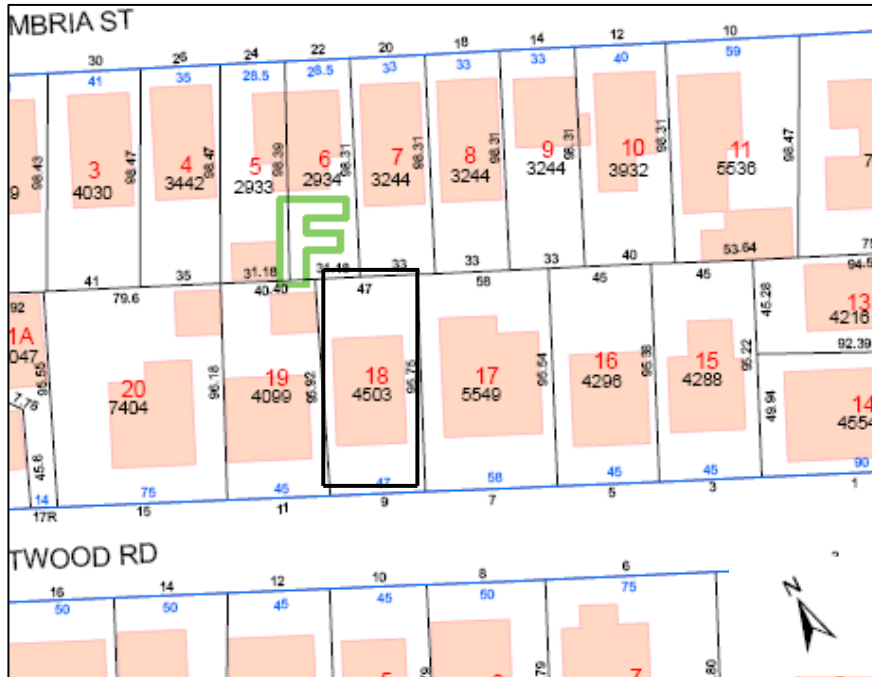
9 Westwood Road

The walkway running from the street to the front door is extremely visible.
