**Addendum #1 – IFB 16-69**

To: All Parties on Record with the City of Somerville as Holding IFB 16-69 Milk Row Cemetery Tomb Façade Rehabilitation

## **IFB 16-69 Milk Row Cemetery Tomb Facade Rehabilitation Addendum No. 1**

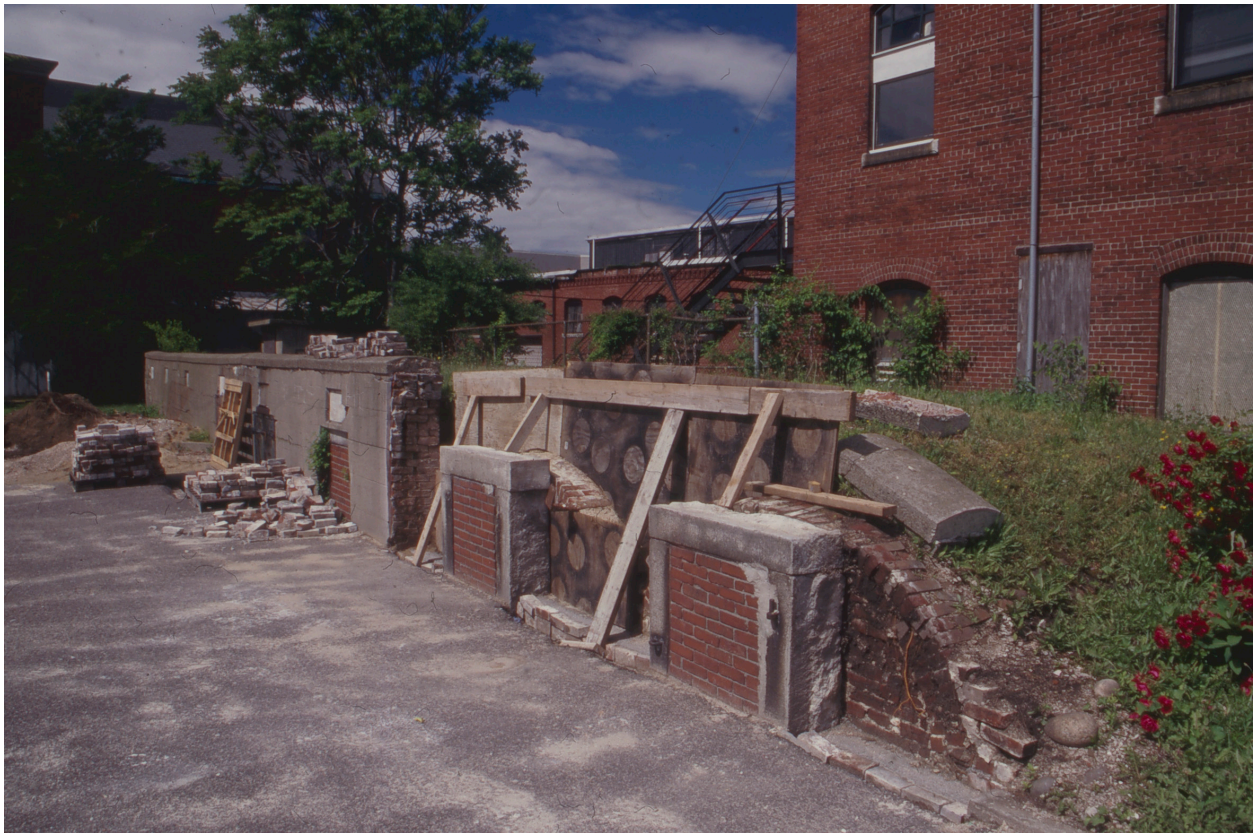
*A. The intent is to protect the tombs and protect the contents of the tombs [if any] while the tomb facades are down. The photo below illustrates how this was accomplished in the past. A secure alternative to providing guard and watchman services as noted in Section 01 50 00 paragraph 1.07 is desirable.*

*A. Cover tomb openings with braced plywood and bagged sand to protect the interior until work is complete.*
